Preliminary archaeological observations at Ty Coch locks, Cwmbran, 2016

Summary:

In July 2016, the existence of an extensive deposit containing significant amounts of nineteenth-century domestic material was recorded during shallow excavations to create paths and a seating area beside Lower Brake Lock, Ty Coch, Monmouthshire. The finds suggest a continuous nearby occupation by people who could afford a modicum of decorated ceramics and other fashionable objects.

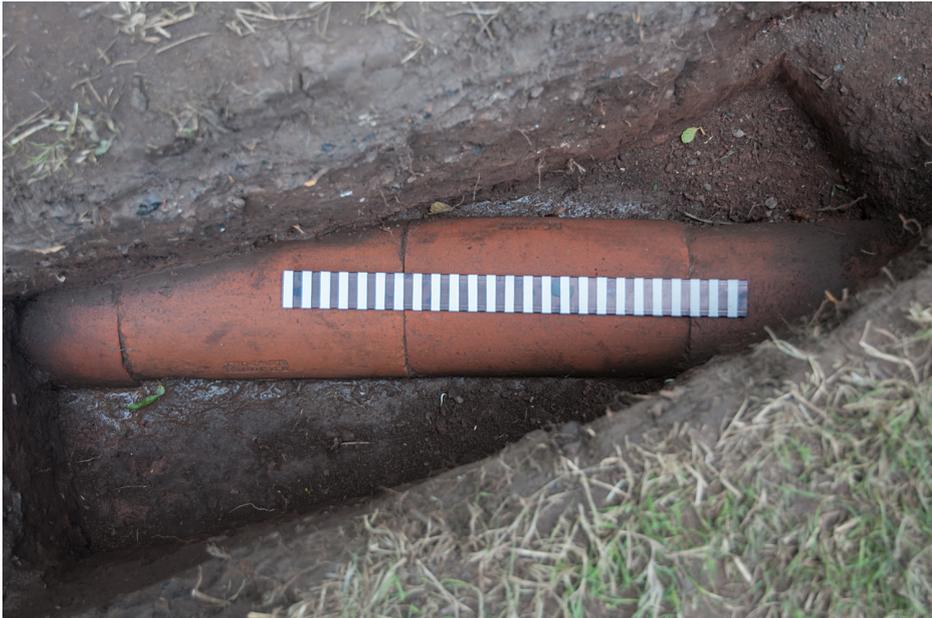
Figure 5: Terracotta pipe exposed in circular trench.

A terracotta pipe was encountered in the base of the circular trench (Figure 5). The pipe sections, which were stamped "R.P. Jones Newport", were butt-jointed (Figures 5 and 6), were 0.18m ($\pm 7''$) in diameter and 0.31m ($\pm 12''$) long. The interior of the pipe was dry and empty of silt. The pipeline sloped towards the south.

The normal function of a butted drain pipe of this kind would be to improve the drainage of cultivated or waterlogged soils. That it may have replaced or enhanced an earlier, less sophisticated drain suggests that it served a significant purpose. However the area already slopes markedly to the south, and shows little sign of being waterlogged. A pipeline intended to allow the passage of running water would have normally been constructed of jointed and glazed pipes (such as that discovered during the 2014 excavation). While the stone-filled drain could be much earlier, "tile pipes" like that found were not introduced until well into the nineteenth century, and were not used after about 1890. The dating of the ceramic pipe to the nineteenth century means that the drainage post-dates the construction of the locks. R.P. Jones was listed as Portuguese Vice Consul for Newport in 1836 (Anon 1836) and occasional newspaper mentions indicate that an R.P. Jones was active in Newport in the late nineteenth century, though it has not been possible so far to link these with drainage pipe manufacture. The purpose of the drains remains unexplained.

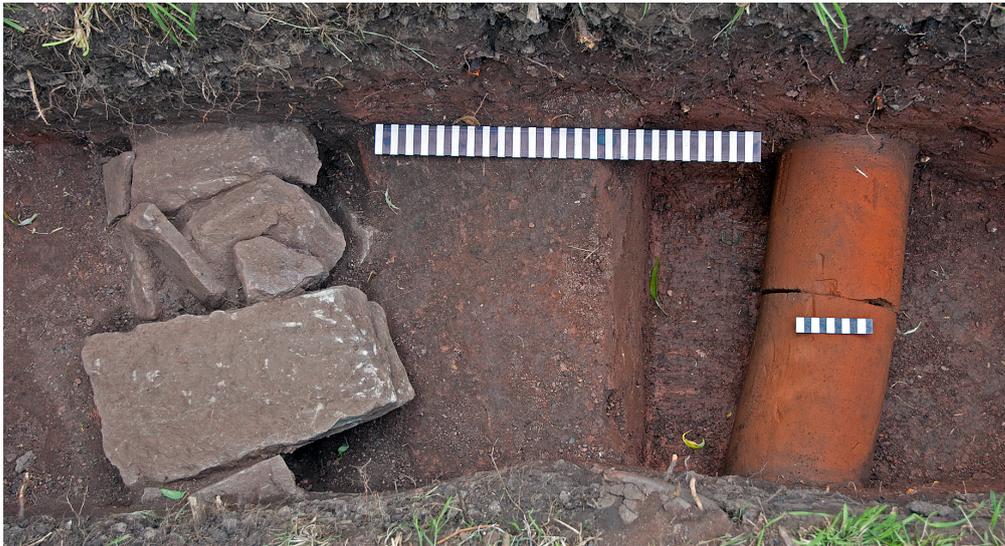
Figure 7: “French” drain (left) and terracotta drain (right).

To confirm the line of the drain a 2.0m x 0.5m trench was dug E-W 2m to the north of the circular trench. In this trench, immediately to the west of the pipeline, a "French" drain constructed of a small stone-filled trench 0.35m wide also ran towards the south (Figure 7). It was not possible to ascertain at this point whether the ceramic drain was parallel to an/or later than the stone-filled drain, although they appeared to be converging. The stone-filled drain was not found in the circular trench to the south. Though land drainage would normally involve a number of parallel pipes, because of the limited scope of the excavation it was not possible at that time to identify any other nearby drainpipes.

4. A small e-w trench to the north of the circular trench (Figure 7).
 - a. This trench was excavated to a depth of approx. 0.5m in order to confirm the line of a drain-pipe discovered in the circular trench.

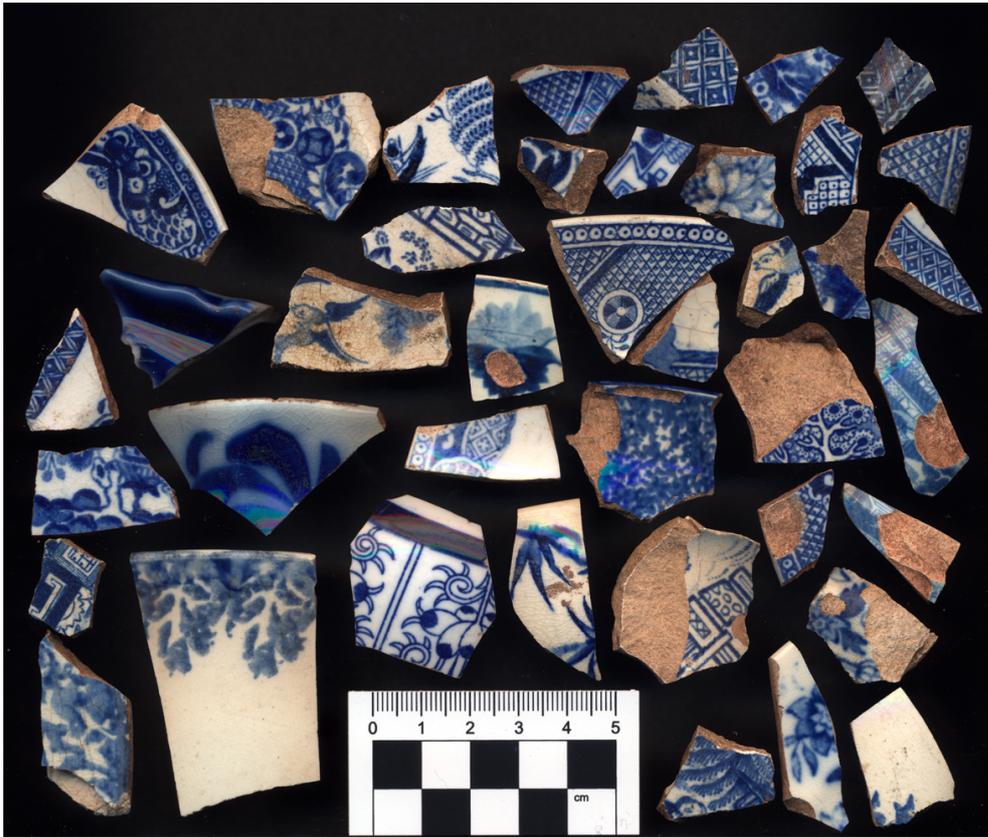
Figure 9: Dark blue decorated ceramics from 4m square trench.

Although the deposits have been affected by recent disturbance, most of the material found dates from the nineteenth century. The number of twentieth century and more recent objects was surprisingly small, given that the area was a designated picnic spot in the 1970s, and that 1980s material was found associated with the saw pit (Burchell ND, 37). However the presence of generally earlier light blue (Figure 8) as well as later dark blue (Figure 9) decorated ceramics suggests that there was a continuous rate of deposition throughout the century.

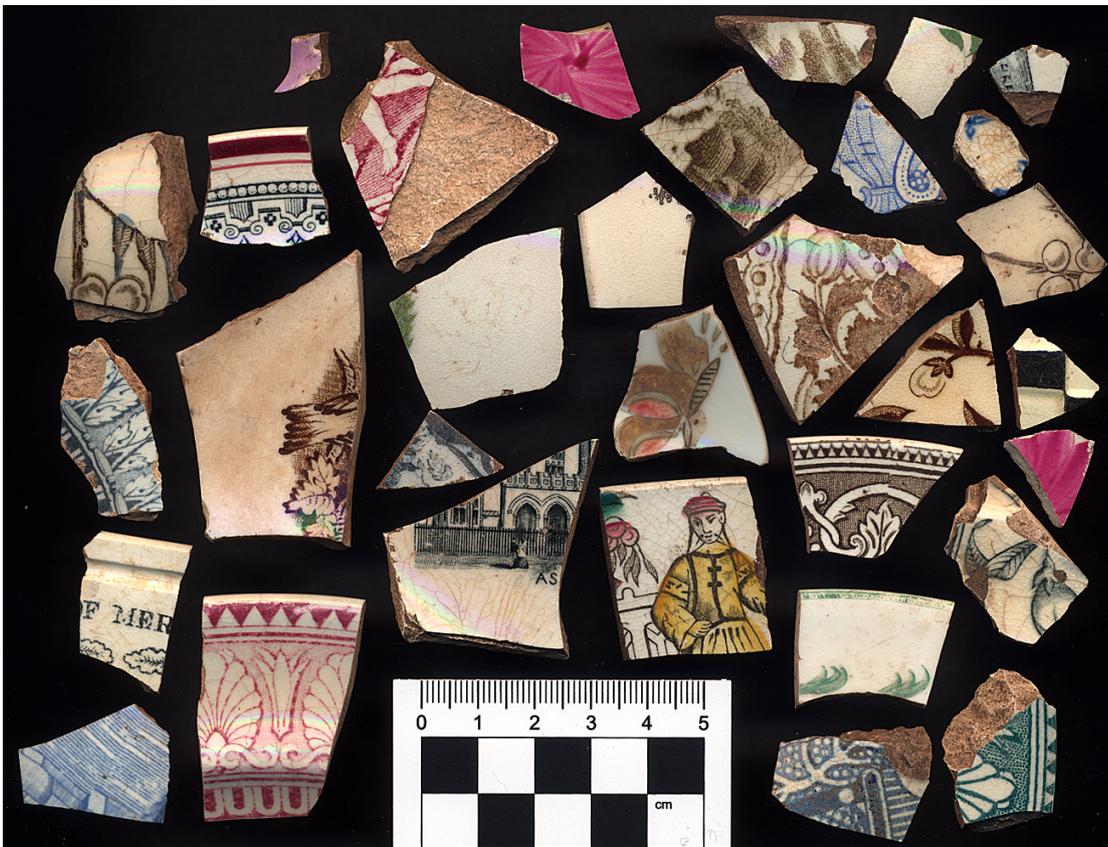
Figure

9: Transfer-printed and coloured ceramics from 4m square trench.

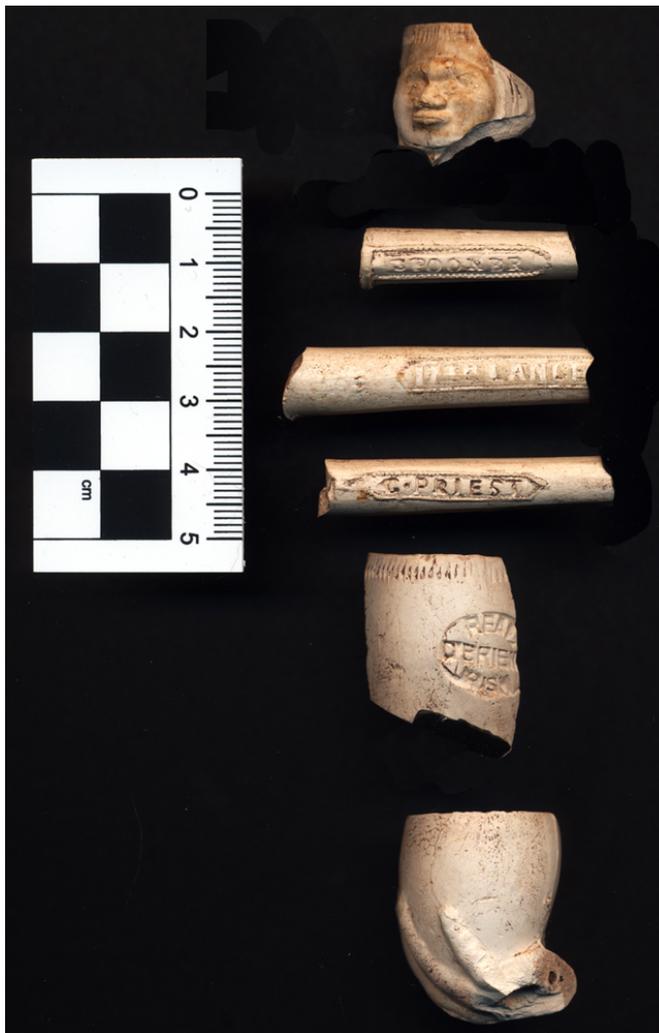
Figure 10: Examples of clay tobacco smoking pipes from 4m square trench.

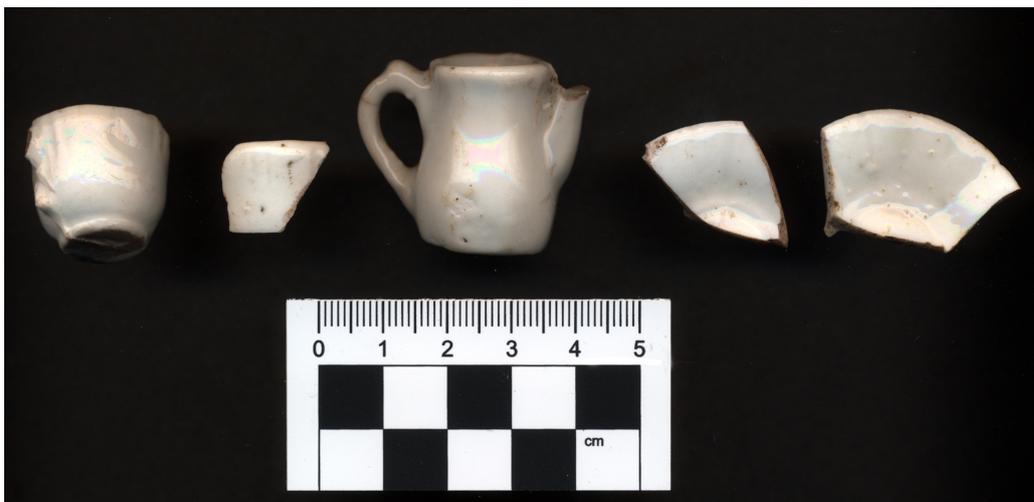
Figure 11: Miniature vessels from 4m square trench.

The occurrence of miniature ceramics (Figure 11) is usually taken to indicate the presence of children, and this may be true in this case, though some archaeologists, including the author (Mills 2017, 431), have warned against this assumption, pointing to the popularity of these objects amongst adults.
